**FIRE SAFETY FOLLOW UP INSPECTION**

Factory Name	STERLING APPARELS LTD		Accord ID	9619
Address	Beron, Earpur Union, Ashulia, Savar			
Inspection Date	25/03/2014		Report Received Date	
Date of 1st Follow-up	23-April/15	Date of 2nd Follow-up	20-January/16	
Date of 3rd Follow-up	02-May/16	Date of 4th Follow-up	26-July/16	
Date of 5th Follow-up	08-November/16	Date of 6th Follow-up	12-January/17	
Date of 7th Follow-up	12-April/17	Date of 8th Follow-up	25-July/17	
Date of 9th Follow-up	19-December/17	Date of 10th Follow-up		
Inspected by	Md. Mah mudur Rahman

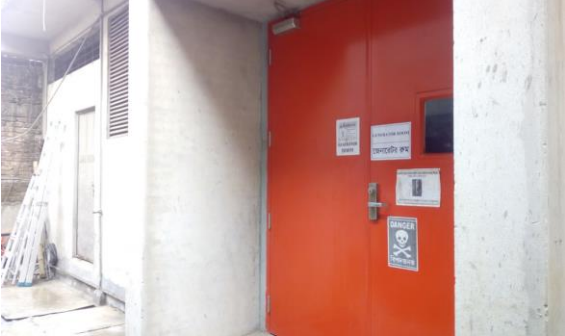
Item No	Accord Observation	Accord Recommendation	Timeline given by Accord	Comments after Physical Inspection	Supposed to complete(DD /MM/YYYY)	Final Action Plan (Factory)	Status on the date of Inspection	Pictorial Evidence
1	The generator room is not separated by fire-rated construction and openings, non-rated doors, penetrations.	Separate the generator room by a minimum 2-hr fire-rated construction. Seal and protected all openings to maintain the required fire separations	Within 3 months	<p>On 20/01/2016: Corrected. Generator room has been separated by Fire rated construction.</p> <p>On 02/05/2016: Corrected.</p> <p>On 26/07/2016: Corrected.</p> <p>On 08/11/2016: Corrected.</p> <p>On 12/01/2017: Corrected</p> <p>On 12-04-2014: Corrected.</p> <p>On 25/07/2017: Corrected.</p> <p>On 19/12/17: Separated</p>	20/01/2016		Corrected

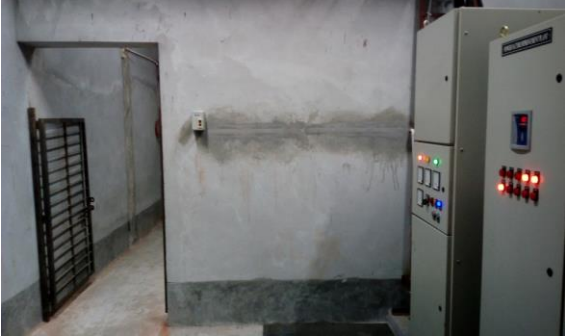
2	The transformer and EMR room is not separated by fire-rated construction and openings, non-rated doors, penetrations.	Separate the transformer room by a minimum 2-hr fire-rated construction. Seal and protected all openings to maintain the required fire separations	Within 3 months	<p>On 20/01/2016: Partially Corrected. Fire door (pending verification) has been installed. Few penetration observed between transformer and EMR room to Building inside. Final</p> <p>On 02/05/2016: Partially Corrected. If factory wants to keep fire door open, proper interfacing is required.</p> <p>On 26/07/2016: Corrected.</p> <p>On 08/11/2016: Corrected.</p> <p>On 12/01/2017: Corrected</p> <p>On 12-04-2014: Corrected.</p> <p>On 25/07/2017: Corrected.</p> <p>On 19/12/17: Separated</p>	02/06/2016		Corrected

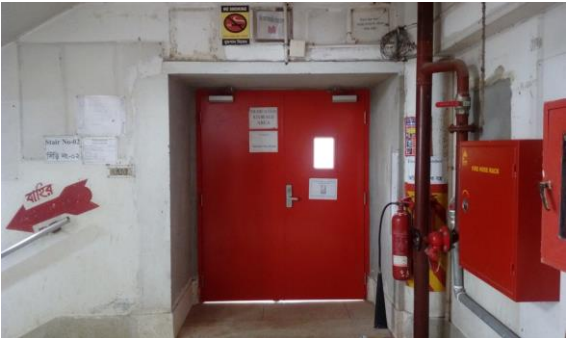
Item No	Accord Observation	Accord Recommendation	Timeline given by Accord	Comments after Physical Inspection	Supposed to complete(DD /MM/YYYY)	Final Action Plan (Factory)	Status on the date of Inspection	Pictorial Evidence
5	The all exit stair are not separated from work areas and other spaces on each floor by firerated construction.	Provide minimum 1.5-hr fire rated doors and seal all unprotected openings to separate the exit stairs from work areas and other building spaces on all floor levels. Ensure that the fire doors are self-closing and positive latching and that they are provided with fire exit (panic) hardware where serving production floors. If fire doors are required to be held open for functional reasons, provide automaticclosing devices tied to the fire alarm system.	Within 3 months	<p>On 02/05/2016: Partially Corrected. Fire doors were found open during inspection. If factory wants to keep fire doors open, interfacing with addressable fire alarm system is required.</p> <p>On 26/07/2016: Corrected. During inspection time fire doors have been found on closed.</p> <p>On 08/11/2016: Corrected. Note: Few Door co-coordinator were found non functional. Factory should regularly inspect and test the proper functionality/integrity of the fire doors.</p> <p>On 12/01/2017: Corrected</p> <p>On 12-04-2014: Corrected. Note: If the factory needs to keep the door open then the doors shall be interfaced with FACP.</p> <p>On 25/07/2017: Corrected. Provide clear egress from external exit to exit discharge.</p> <p>On 19/12/17: Separated.</p>	02/06/2016		Corrected

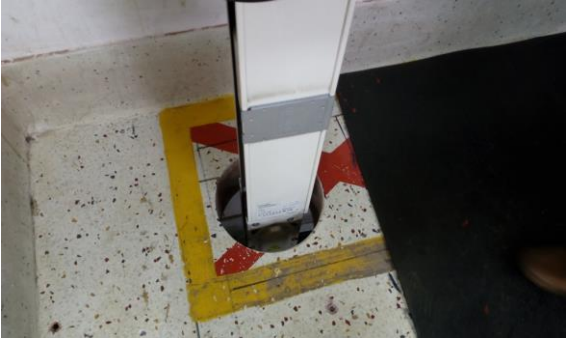
6	Unsealed penetrations and openings are located in the fire-rated floor and ceiling assemblies.	Provide a minimum 2-hr fire-rated shaft to separate the utility risers from each floor level. Seal all penetrations and openings in floor and ceiling assemblies to maintain the fire separation.	Within 3 months	<p>On 20/01/2016: Partially corrected. Unsealed penetration in the ceiling has been sealed on stair area. The utility riser shaft has been covered by artificial board with no fire rating certification presented.</p> <p>On 02/05/2016: Partially Corrected. Factory shall replace non rated covering materials with proper fire rated coverings.</p> <p>On 26/7/2016: Corrected.</p> <p>On 08/11/2016: Corrected.</p> <p>On 12/01/2017: Corrected</p> <p>On 12-04-2014: Corrected. Not found.</p> <p>On 25/07/2017: Corrected.</p> <p>On 19/12/17: <b>Found due to installation BBT.</b></p>	02/06/2016		Corrected

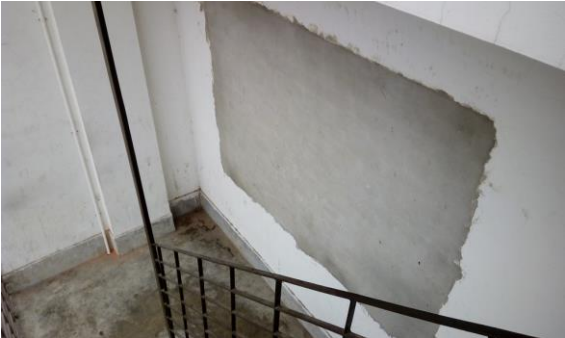
Item No	Accord Observation	Accord Recommendation	Timeline given by Accord	Comments after Physical Inspection	Supposed to complete(DD/MM/YYYY)	Final Action Plan (Factory)	Status on the date of Inspection	Pictorial Evidence
7	Unsealed penetrations and openings are located in all exit stair enclosures.	Seal all penetrations and openings in exit stair enclosure walls to maintain the fire separation.	Within 3 months	<p>On 20/01/2016: Partially Corrected. Civil work has been completed in all the previously unsealed area except one unprotected openings observed on 1st floor of the South stair of the building.</p> <p>On 02/05/2016: Corrected. Factory has sealed unprotected openings.</p> <p>On 26/7/2016: Corrected.</p> <p>On 08/11/2016: Corrected.</p> <p>On 12/01/2017: Corrected</p> <p>On 12-04-2014: Corrected. Not found.</p> <p>On 25/07/2017: Corrected.</p> <p>On 19/12/17: Completed</p>	02/05/2016		Corrected

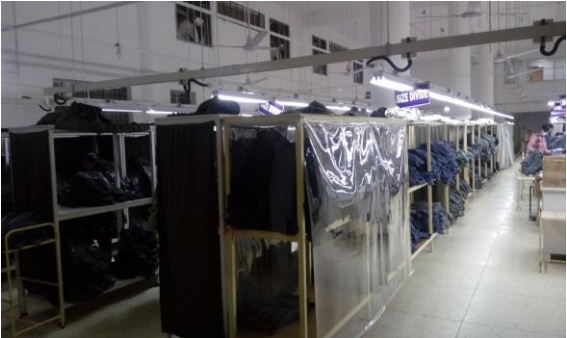
Item No	Accord Observation	Accord Recommendation	Timeline given by Accord	Comments after Physical Inspection	Supposed to complete(DD/MM/YYYY)	Final Action Plan (Factory)	Status on the date of Inspection	Pictorial Evidence
9	Areas used for combustible storage are not separated by fire-rated construction.	Provide dedicated storage rooms separated by minimum 1-hr fire-rated construction. Where separate storage rooms are not feasible, provide defined storage areas and limit the storage arrangement as follows: - Maximum height of 2.4m and maximum area of 23m <sup>2</sup> - If sprinkler protected: maximum height of 3.66m and maximum area of 93m <sup>2</sup> Separate areas of unenclosed combustible storage by a minimum clear distance of 3m.	Within 3 months	On 20/01/2016: No action has been taken yet. On 02/05/2016: No action has been taken yet. On 26/7/2016: It has been found same as it was before. On 08/11/2016: Observed same as last follow-up. On 12/01/2017: It was found same as before.  On 12-04-2014: Corrected. Factory was maintaining. On 25/07/2017: Corrected. On 19/12/17: Completed. Maintaining defined storage areas.	02/06/2016		Corrected

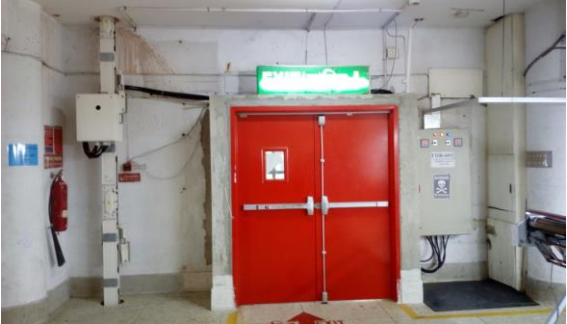
10	Egress doors and gates with locking features are provided at all exit doors.	Remove locking features from all egress doors and gates. If locks are required for security reasons, utilize special door locking features complying with NFPA 101.	Immediate	On 20/01/2016: Corrected. On-standard locking features were removed from exit doors. On 02/05/2016: Corrected. On 26/7/2016: Corrected. On 08/11/2016: Corrected. On 12/01/2017: Corrected  On 12-04-2014: Corrected . On 25/07/2017: Corrected. On 19/12/17: Removed	20/01/2016		Corrected

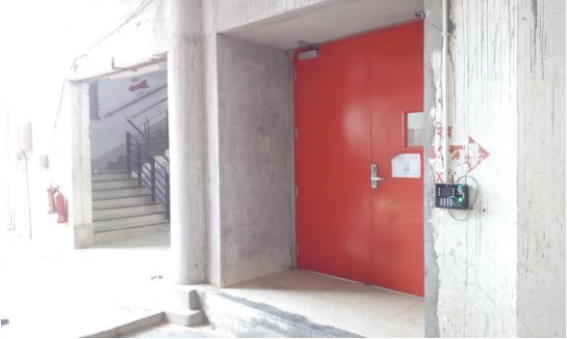
11	Collapsible gates and sliding doors are provided at all exit doors.	Replace all gates and sliding doors along the means of egress with side-hinged, swinging egress doors. If locks are required for security reasons, utilize special door locking features complying with NFPA 101.	Within 1 months	On 20/01/2016: Corrected. Collapsible gates and sliding doors were removed from exit doors. On 02/05/2016: Corrected. On 26/7/2016: Corrected. On 08/11/2016: Corrected. On 12/01/2017: Corrected  On 12-04-2014: Corrected. On 25/07/2017: Corrected. On 19/12/17: Removed	20/01/2016		Corrected

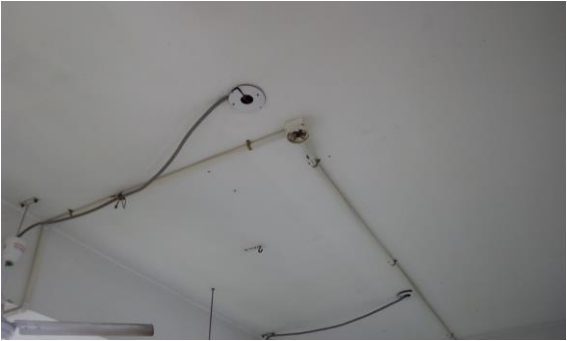
Item No	Accord Observation	Accord Recommendation	Timeline given by Accord	Comments after Physical Inspection	Supposed to complete(DD/MM/YYYY)	Final Action Plan (Factory)	Status on the date of Inspection	Pictorial Evidence
12	The fire alarm system is antiquated, not a listed system, and does not provide alarm and notification features consistent with acceptable standards.	Replace the fire alarm system with a new, listed addressable fire alarm system in accordance with NFPA 72.	Design within 4 months, install within 9 months	<p>On 20/01/2016: In progress. Drawing has been submitted to Accord.</p> <p>On 02/05/2016: In progress. Factory has reviewed the fire alarm system drawing from ACCORD. Installation shall be completed within committed timeline.</p> <p>On 26/07/2016: Still installation is not started.</p> <p>On 08/11/2016: Installation in progress. About 30-40% cabling work for FA system has been completed.</p> <p>On 12/01/2017: System wiring is completed &amp; pretty soon will start the system installation.</p> <p>On 12-04-2014: Installation is in progress. Factory shall submit 3rd party documents of all the products.</p> <p>On 25/07/2017: Installation has been in progress.</p> <p>On 19/12/17: Installation near to finish.</p>	02/06/2016		In Progress

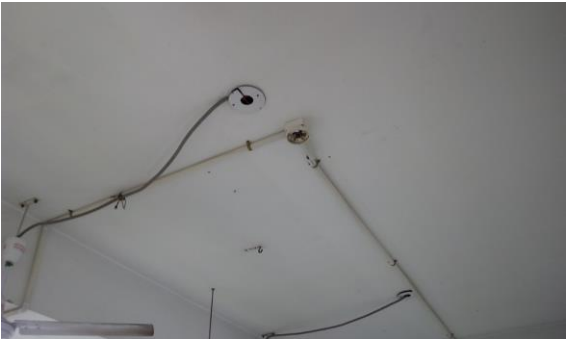
Item No	Accord Observation	Accord Recommendation	Timeline given by Accord	Comments after Physical Inspection	Supposed to complete(DD/MM/YYYY)	Final Action Plan (Factory)	Status on the date of Inspection	Pictorial Evidence
15	The building is equipped with single-station smoke alarms. Smoke alarm activation sounds only a local alarm and does not provide automatic fire alarm notification of occupants.	Replace the single-station smoke alarms with automatic smoke detectors tied into the fire alarm system. Configure the fire alarm system to initiate occupant notification upon activation of any two smoke detectors in addition to the manual fire alarm stations.	Within 6 months	<p>On 20/01/2016: It is an integrated part of fire alarm system.</p> <p>On 02/05/2016: It is integrated part of fire alarm system.</p> <p>On 26/7/2016: It is integrated part of fire alarm system.</p> <p>On 08/11/2016: It is an integrated part of fire alarm system.</p> <p>On 12/01/2017: It is an integrated part of Fire Alarm &amp; Detection System.</p> <p>On 12-04-2017: It is an integrated part of fire alarm system.</p> <p>On 25/07/2017: It is an integrated part of fire alarm system.</p> <p>On 19/12/17: Installation near to finish</p>	02/06/2016		In Progress

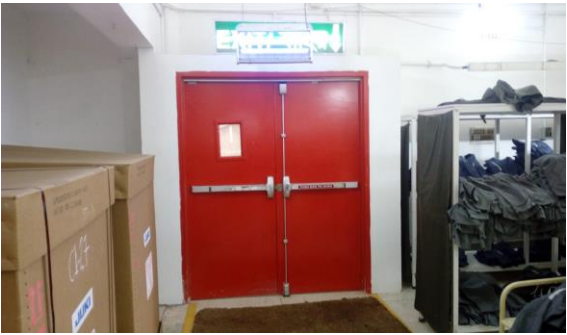
16	Exit sign not provided at exit in ground floor.	Provide exit signs above all exits to the exterior and all doors to the exit stairs.	Within 3 months	<p>On 20/01/2016: Corrected. Exit sign observed at exit in Ground floor.</p> <p>On 02/05/2016: Corrected.</p> <p>On 26/7/2016: Corrected.</p> <p>On 08/11/2016: Corrected.</p> <p>On 12/01/2017: Corrected</p> <p>On 12-04-2014: Corrected.</p> <p>On 25/07/2017: Corrected.</p> <p>On 19/12/17: Provided</p>	20/01/2016		Corrected

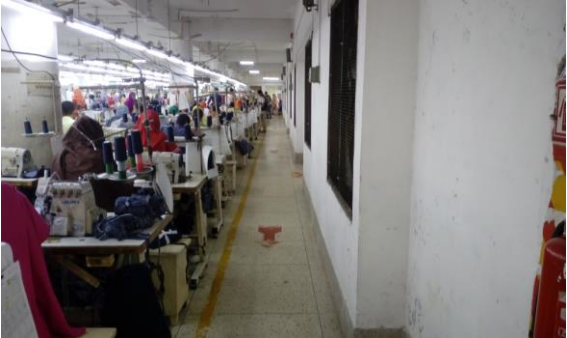
18	New Finding: The egress path along means of egress has interrupted by obstruction/storage. Aisle at 5th and 6th floor and Egress passageway of South exit stair discharge.	<p>Means of egress shall be maintained continuously free and clear of all obstructions/storage.</p> <p>Or</p> <p>Keep egress paths and stairs clear of storage.</p>	Within 1 months	<p>On 02/05/2016: In progress. Egress passageway of south exit discharge was found clear. But aisles at few floors shall be corrected.</p> <p>On 26/07/2016: Egress pass way of south exit stair has been found same as before.</p> <p>On 08/11/2016: Not corrected. Still a few aisles has been found with clear width of less than 36 inch.</p> <p>On 12/01/2017: Egress aisles on 5th &amp; 6th Floor was found less than 36 in. at several locations. Exit passageway from South Exit stair was not separated from building interior.</p> <p>On 12-04-2014: Work is in progress.</p> <p>On 25/07/2017: In progress.</p> <p>On 19/12/17: Completed</p>	02/06/2016		Corrected

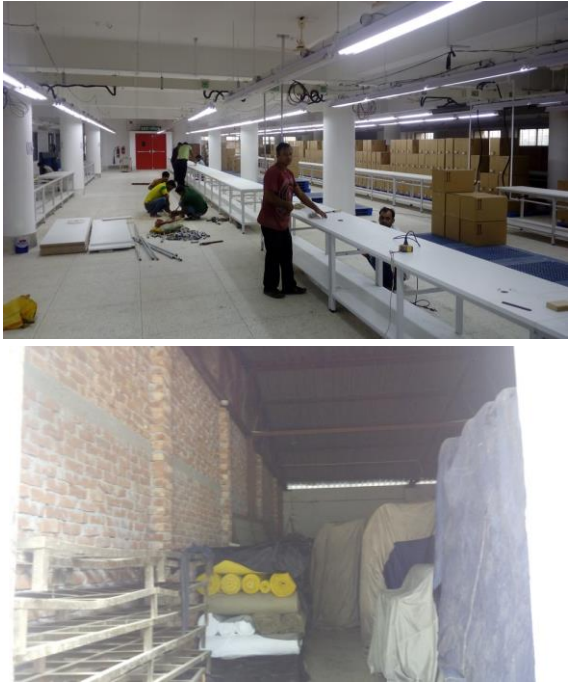
20	New Finding (3rd Follow up) : Rooms used for combustible storage are not separated by fire rated construction.	Provide dedicated storagerooms separated by minimum 1-hr fire-rated construction. Where separate storagerooms are not feasible, provide defined storage areas and limit the storage arrangement as follows:- Maximum height of 2.4m and maximum area of 23m <sup>2</sup> - If sprinkler protected: maximum height of 3.66m and maximum area of 93m <sup>2</sup> Separate areas of unenclosed combustible storage by a minimum clear distance of 3m.	Within 1 month	On 02/05/2016: New Finding On 26/07/2016: Storage area shifted to dedicated area at 1st floor. On 08/11/2016: Corrected. On 12/01/2017: Corrected  On 12-04-2014: Corrected. Factory shall update the checklist according to standard. On 25/07/2017: Corrected. On 19/12/17: Maintaining	02/06/2016		Corrected

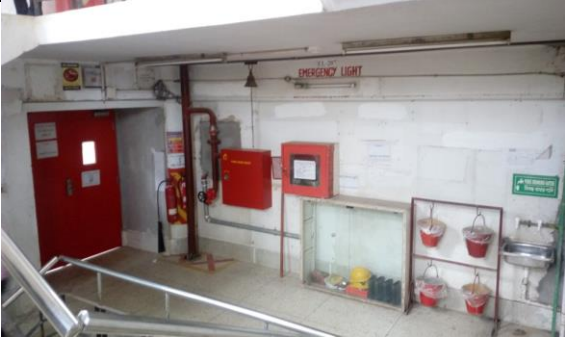
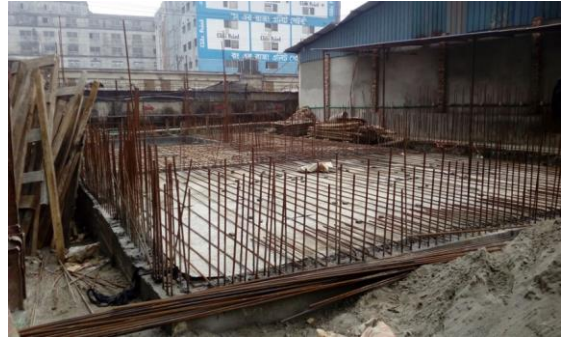
Item No	Accord Observation	Accord Recommendation	Timeline given by Accord	Comments after Physical Inspection	Supposed to complete(DD /MM/YYYY)	Final Action Plan (Factory)	Status on the date of Inspection	Pictorial Evidence
21	<p>New Finding: The existing factory building with an occupiable floor greater than 10 m (33 ft) above the finished grade is not protected with an approved standpipe system.</p>	<p>Provide a standpipe system throughout the building in accordance with NFPA 14. ( design already reviewed from Accord)</p>	<p>Within 5 months (for installation )</p>	<p>On 26/7/2016: New finding On 08/11/2016: In progress. Order has been placed for Stand-pipe system however material are not in house yet. UWR (Underground water reservoir) construction is on-going. On 12/01/2017: Materials are in-housed and pretty soon will start the system installation.</p> <p>On 12-04-2014: Installation is in progress. Factory shall submit 3rd party documents of fire pump. On 25/07/2017: Installation has been in progress. On 19/12/17: Installation is in progress</p>	26/12/2016		In Progress

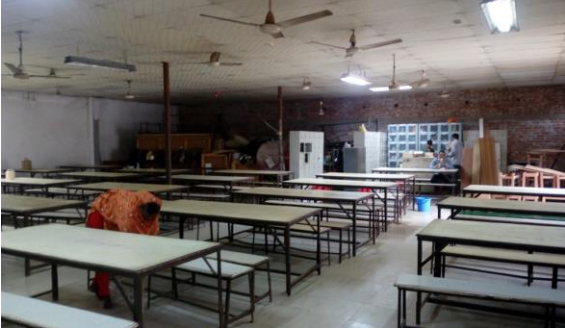
22	<p>New Finding (5th Follow-up): Dinning space is not separated from storage area by Fire rated construction. Location: Dinning Shed</p>	<p>Remove dinning space from this location or, Alternatively, Provide minimum 2-hour fire rated separation.</p>	<p>Within 1 month</p>	<p>On 08/11/2016: New Finding On 12/01/2017: Partial separation (Brick partition) has been provided between Dining facilities &amp; store room</p> <p>On 12-04-2014: Work is in progress. On 25/07/2017: Corrected. Fire rated separation has been provided to storage area. On 19/12/17: Separated</p>	08/12/2016		Corrected
