Structural Safety Inspection

Factory Name	STERLING APPARELS LTD	Accord ID	9619
Factory Address	Beron, Earpur Union, Ashulia, Savar		
Inspection Date	12/03/2014		
Date of Review Inspection	18-Jan-18		
Inspected by	Md. Abu Zafar-Al-Mansur

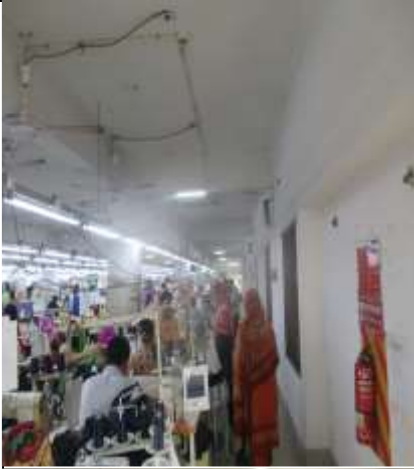
Item No	Accord Observation	Accord Recommendation	Accord Timeline	Final Action Plan	Final Timeline(DD/MM/YYYY)	Comments after Physical Inspection	Progress Status	Pictorial Evidence
2	Long spanning cantilever with signs of distress.	Reduce Cantilever loading & commence DEA as per item 1 above. Priority 2	Immediate - Now		30/08/2015	<p>On 23/4/15: The factory management removed the load from the cantilever portion.</p> <p>On 2/5/16: Comments are same as previous follow-up inspection. They have also completed DEA of the building which was accepted by ACCORD on 21st April, 2016.</p> <p>ON 17/08/2016: During inspection, loading on the cantilever found reduced. DEA of the factory building was accepted on 21st April, 2016.</p> <p>On 18-Jul-2017: DEA has been accepted from ACCORD on 21st April, 2016. Loading was found below the allowable load limit.</p> <p>On 18-Jan-2018: Corrected from previous inspection. During inspection, load was observed below allowable limit mention in accepted load plan.</p>	Corrected

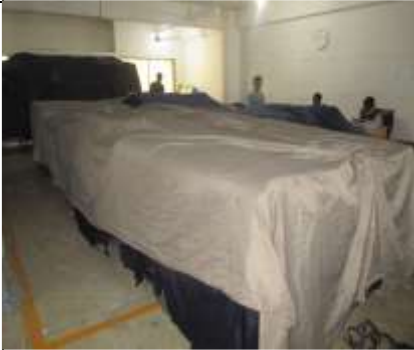
3	Vertical extension of canteen area on roof	Reduce loading as per item 1 requirements.	Immediate - Now		30/09/2015	<p>On 23/4/15: The factory management removed the load from the cantilever portion.</p> <p>On 2/5/16: Comments are same as previous follow-up inspection.</p> <p>ON 17/08/2016: Corrected from previous follow up inspection report.</p> <p>On 18-Jul-2017: DEA has been accepted from ACCORD on 21st April, 2016. Loading was found below the allowable load limit.</p> <p>On 18-Jan-2018: Corrected from previous inspection. During inspection, load was observed below allowable limit mention in accepted load plan.</p>	Corrected

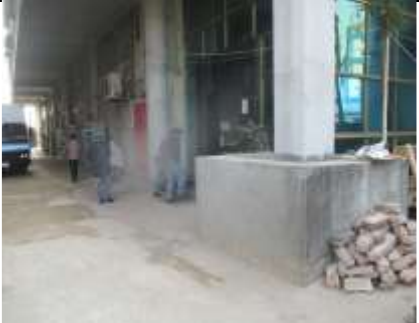
5	Horizontal extension on east façade.	Reduce loading as per item 1 requirements.	Immediate - Now		30/10/2015	<p>On 23/4/15: The factory management removed the load from the cantilever portion.</p> <p>On 2/5/16: Comments are same as previous follow-up inspection.</p> <p>On 17/08/2016: Corrected from previous follow up inspection.</p> <p>On 18-Jul-2017: DEA has been accepted from ACCORD on 21st April, 2016. Loading was found below the allowable load limit.</p> <p>On 18-Jan-2018: Corrected from previous inspection. During inspection, load was observed below allowable limit mention in accepted load plan.</p>	Corrected	
6	Protection of critical element adjacent to vehicular access	Place temporary warning /protection (e.g. traffic cone, sand filled barrels as deemed appropriate by Building Engineer) at 1m from column faces.	Immediate - Now	we have already taken protection measures. Calculation of sufficiency of the protection structure will be given in the DEA	30/08/2015	<p>On 23/4/15: The factory management installed a temporary structure for the protection of the columns but did not show any documents suggested by the engineer.</p> <p>On 2/5/16: They have provided temporary warning/ protection by a brick wall and a warning sign was there.</p> <p>On 17/08/2016: Corrected from previous follow up inspection.</p> <p>On 18-Jul-2017: This issue has been corrected from 2nd follow up inspection.</p> <p>On 18-Jan-2018: Corrected from previous inspection.</p>	Corrected

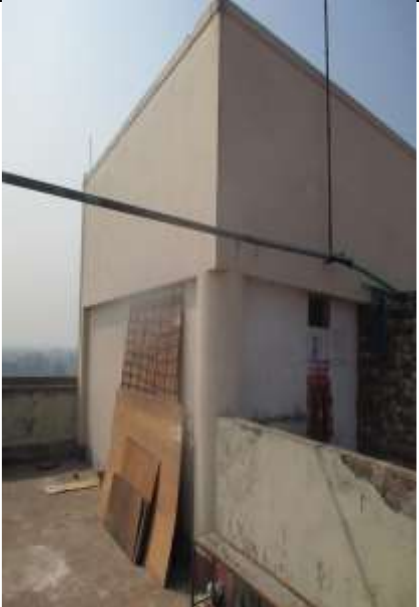
Item No	Accord Observation	Accord Recommendation	Accord Timeline	Final Action Plan	Final Timeline(DD/MM/YYYY)	Comments after Physical Inspection	Progress Status	Pictorial Evidence
8	Cracking to water tank support columns	Detail Engineering Assessment to be completed as per item 1.	within 6-weeks	we have already checked the cracked zone by removing plaster from that area and found that the cracks are only in the plaster. Frame structure was found completely intact. Pictorial evidences will be attached in the DEA	24/04/2015	<p>On 23/4/15: This issue will be covered in DEA. The factory management submitted the DEA to Accord on 16 february-2015.They were asked to resubmit the DEA with some corrections. On verification the factory management said that they will re-submit the DEA within 5 May-2015</p> <p>On 2/5/16: According to factory management, they have investigated the cracks and found they were plaster cracks only and they plastered it. However, during inspection crack at some places were still visible and its inclusion in DEA could not be verified during inspection. Final decision regarding this issue will be taken after DEA verification.</p> <p>ON 17/08/2016: Factory has completed DEA which was accepted by ACCORD on 21th April, 2016.</p> <p>On 18-Jul-2017: DEA has been accepted from ACCORD on 21st April 2016. Factory completed all the remedial works till date.</p> <p>On 18-Jan-2018: Corrected from previous inspection.</p>	Corrected

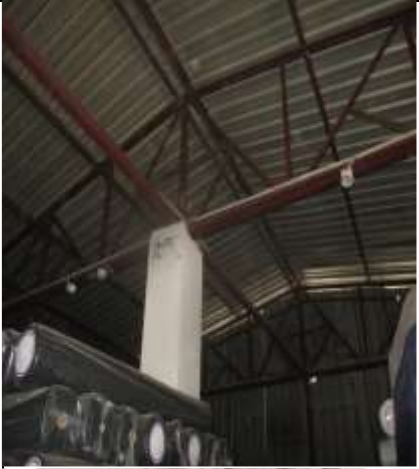
Item No	Accord Observation	Accord Recommendation	Accord Timeline	Final Action Plan	Final Timeline(DD/MM/YYYY)	Comments after Physical Inspection	Progress Status	Pictorial Evidence
9	Lateral Stability of Single Storey Warehouse Building	Building Engineer to verify that building has an appropriate lateral stability system and submit relevant design documents	within 6-weeks	This item will be covered in the DEA	30/08/2015	<p>On 23/4/15: This issue will be covered in DEA. The factory management submitted the DEA to Accord on 16 february-2015.They were asked to resubmit the DEA with some corrections. On verification the factory management said that they will re-submit the DEA within 5 May-2015</p> <p>On 2/5/16: This issue was covered and DEA and analysis report was available. Final decision regarding this issue will be taken after DEA verification.</p> <p>ON 17/08/2016: This issue was covered by DEA. DEA of the factory has been accepted by ACCORD.</p> <p>On 18-Jul-2017: This issue has been corrected in the previous follow up inspection.</p> <p>On 18-Jan-2018: Corrected from previous inspection.</p>	Corrected

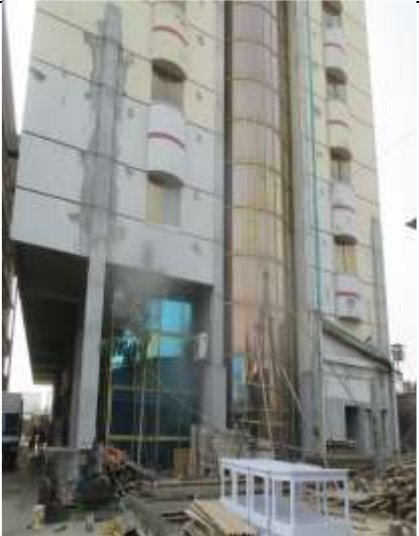
10	Long spanning cantilever with signs of distress.	Detail Engineering Assessment to be completed as per item 1.	6-weeks	This item will be covered in the DEA	30/08/2015	<p>On 23/4/15: This issue will be covered in DEA. The factory management submitted the DEA to Accord on 16 february-2015.They were asked to resubmit the DEA with some corrections. On verification the factory management said that they will re-submit the DEA within 5 May-2015</p> <p>On 2/5/16: During inspection sign of distress was visible in the cantilever portion, specifically on the 7th floor. Inclusion of these issues could not be verified in the field during inspection. Final decision regarding this issue will be taken after DEA verification.</p> <p>ON 17/08/2016: Factory has completed DEA which was accepted by ACCORD.</p> <p>On 18-Jul-2017: DEA has been accepted from ACCORD on 21st April 2016. Factory completed all the remedial works till date.</p> <p>On 18-Jan-2018: Corrected from previous inspection.</p>	Corrected

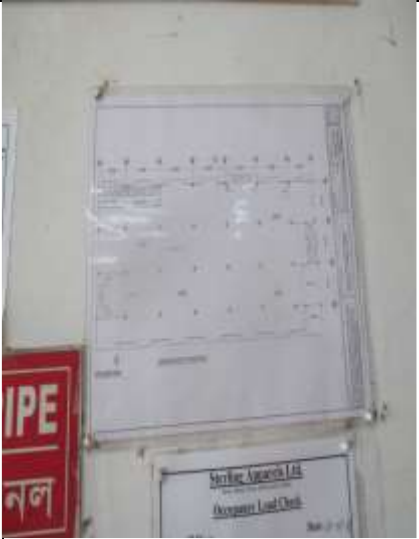
Item No	Accord Observation	Accord Recommendation	Accord Timeline	Final Action Plan	Final Timeline(DD/MM/YYYY)	Comments after Physical Inspection	Progress Status	Pictorial Evidence
12	Long spanning cantilever with signs of distress.	Building Engineer to prepare Allowable Floor Loading Plans.	6-months	This item will be covered in the DEA	30/08/2015	<p>On 23/4/15: This issue will be covered in DEA. The factory management submitted the DEA to Accord on 16 february-2015.They were asked to resubmit the DEA with some corrections. On verification the factory management said that they will re-submit the DEA within 5 May-2015</p> <p>On 2/5/16: Their consultant provided them temporary load plan before completion of retrofitting and they were posted on walls. After retrofitting load plans were also submitted. Both of them were accepted by ACCORD along with DEA on 21st April, 2016.</p> <p>ON 17/08/2016: Load plan has been prepared along with DEA and accepted by ACCORD.</p> <p>On 18-Jul-2017: This issue has been corrected in the previous follow up inspection.</p> <p>On 18-Jan-2018: Corrected from previous inspection.</p>	Corrected

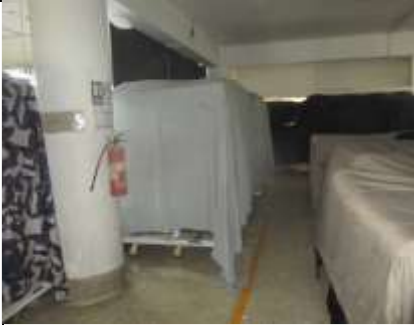
19	Localised areas of high loading.	Reduce loading on areas highlighted for immediate action as per item 1.	Immediate - Now	All loads have been removed already	24/04/2015	<p>On 23/4/15: The factory management removed the load from the cantilever portion.</p> <p>On 2/5/16: Comments are same as previous follow-up inspection.</p> <p>ON 17/08/2016: Corrected from previous follow up inspection report.</p> <p>On 18-Jul-2017: This issue has been corrected in the previous follow up inspection.</p> <p>On 18-Jan-2018: Corrected from previous inspection. During inspection, load was observed below allowable limit mention in accepted load plan.</p>	Corrected

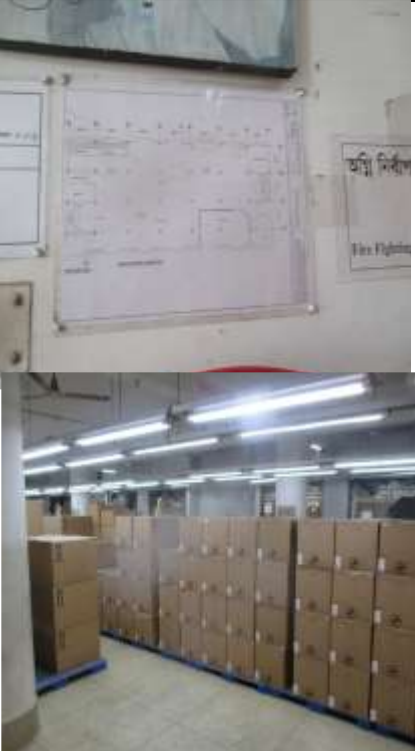
Item No	Accord Observation	Accord Recommendation	Accord Timeline	Final Action Plan	Final Timeline(DD/MM/YYYY)	Comments after Physical Inspection	Progress Status	Pictorial Evidence
21	Localised areas of high loading.	Continue to implement load plan.	6-months	<p>Already Done.</p> <p>With the DEA, we submitted the load plan (after retrofitting) and that has been accepted by ACCORD. We have already completed the retrofitting work and thus we are maintaining that load plan properly.</p> <p>During the last followup- audit, the structural auditor found that the actual load in all areas were below the suggested level of load plan except one room in the mezzanine floor. we moved those storage from there just after the audit. now there is no over loading in any place of the factory.</p>	24/04/2015	<p>On 23/4/15: This issue will be covered in DEA. The factory management submitted the DEA to Accord on 16 february-2015.They were asked to resubmit the DEA with some corrections. On verification the factory management said that they will re-submit the DEA within 5 May-2015</p> <p>On 2/5/16: Their consultant provided them temporary load plan before completion of retrofitting and they were posted on walls. After retrofitting load plans were also submitted. Both of them were accepted by ACCORD along with DEA on 21st April, 2016. During inspection, we found loading was within 20 psf on all floors. Factory management is required to maintain this loading until the completion of remedial works.</p> <p>ON 17/08/2016: Loading plan has been prepared along with DEA and it was accepted from ACCORD. Factory has completed retrofitting of columns as per accepted DEA. During inspection, Loading was found satisfactory according to after retrofitting load plan except slab panel on mezzanine floor. Factory was advised to implement the load plan.</p> <p>On 18-Jul-2017: Floor loading observed below the final load plan.</p> <p>On 18-Jan-2018: Corrected from previous inspection. During inspection, load plan was posted in every floor and load was observed below allowable limit mention in accepted load plan.</p>	Corrected

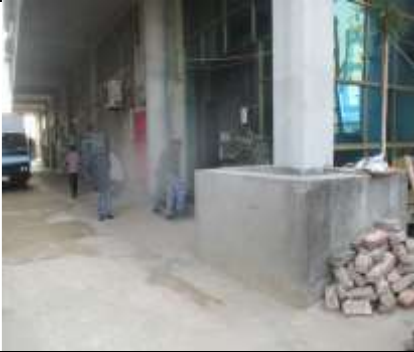
Item No	Accord Observation	Accord Recommendation	Accord Timeline	Final Action Plan	Final Timeline(DD/MM/YYYY)	Comments after Physical Inspection	Progress Status	Pictorial Evidence
22	Protection of critical element adjacent to vehicular access	Place temporary warning /protection (e.g. traffic cone, sand filled barrels as deemed appropriate by Building Engineer) at 1m from column faces.	Immediate - Now	Temporary warning is already placed	24/04/2015	<p>On 23/4/15: The factory management installed a temporary structure for the protection of the columns but did not show any documents suggested by the engineer.</p> <p>On 2/5/16: They have provided temporary warning/ protection by a brick wall and a warning sign was there.</p> <p>ON 17/08/2016: Corrected from previous follow up inspection.</p> <p>On 18-Jul-2017: This issue has been corrected from previous follow up inspection.</p> <p>On 18-Jan-2018: Corrected from previous inspection.</p>	Corrected

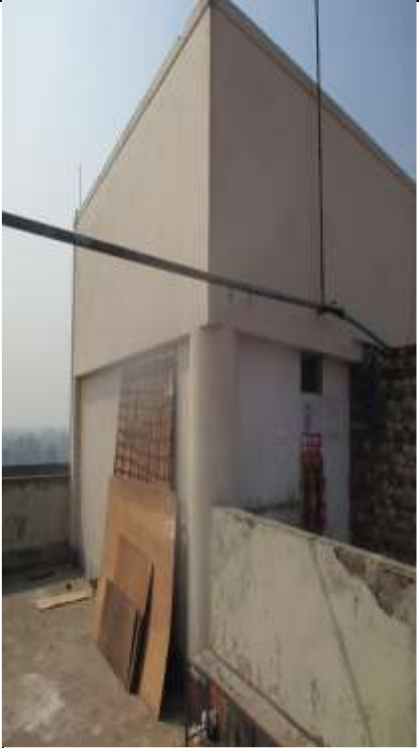
Item No	Accord Observation	Accord Recommendation	Accord Timeline	Final Action Plan	Final Timeline(DD/MM/YYYY)	Comments after Physical Inspection	Progress Status	Pictorial Evidence
33	Cracking observed to water tank support structure	Carry out repair or strengthening as required.	6-months	<p>Already done.</p> <p>In the last CAP verification audit, it was verified by the ACCORD Structural Engineer that the hair line cracks were only on the plaster and the main frame structure in fully intact.</p> <p>The DEA report also shown that the structure is capable of taking load of fully loaded water tank. thus According to DEA no major work is required to strengthen the water tank supporting columns as they are strong enough.</p> <p>however, as there were cracks in the old plaster, we have already removed the old plaster and provided new one.</p>	30/12/2015	<p>On 23/4/15: This issue will be covered in DEA. The factory management submitted the DEA to Accord office on 16 February-2015.They were asked to resubmit the DEA with some corrections. The factory management said that they will re-submit the DEA within 5 May-2015.</p> <p>On 2/5/16: According to the accepted DEA they require some strengthening works in both beams and columns. They will start remedial procedures after DEA verification.</p> <p>ON 17/08/2016: DEA of the factory has been accepted by ACCORD. During inspection, Cracking was observed on water tank supporting columns and these cracks was in plaster. Some repairing was also observed. Factory was advised to repair the cracks as per accepted DEA recommendation.</p> <p>On 18-Jul-2017: As per recommendation from DEA, factory has repaired cracks observed to water tank support structure.</p> <p>On 18-Jan-2018: Corrected from previous inspection.</p>	Corrected

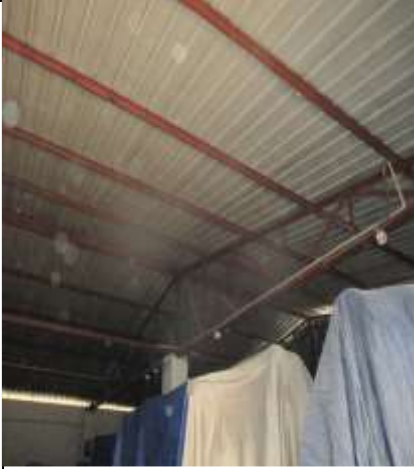
Item No	Accord Observation	Accord Recommendation	Accord Timeline	Final Action Plan	Final Timeline(DD/MM/YYYY)	Comments after Physical Inspection	Progress Status	Pictorial Evidence
34	Lateral Stability of Single Storey Warehouse Building	Building Engineer to verify that building has an appropriate lateral stability system and submit relevant design documents	6-weeks	This item will be covered in the DEA	30/08/2015	<p>On 23/4/15: This issue will be covered in DEA. The factory management submitted the DEA to Accord office on 16 February-2015.They were asked to resubmit the DEA with some corrections. The factory management said that they will re-submit the DEA within 5 May-2015.</p> <p>On 2/5/16: This issue was covered in DEA. DEA was accepted by ACCORD on 21st April, 2016. During inspection, analysis reports were available. Final decision regarding this issue will be taken after DEA verification.</p> <p>ON 17/08/2016: Factory has completed DEA which was accepted by ACCORD.</p> <p>On 18-Jul-2017: DEA has been accepted from ACCORD on 21st April 2016 where this issue was covered.</p> <p>On 18-Jan-2018: Corrected from previous inspection.</p>	Corrected
